## SHORLAND MODIFICATIONS & TIPS (Part 1)

The following is a collection of tips and modifications I have carried out on my Shorland APC Mk1 that may be of interest to other owners.

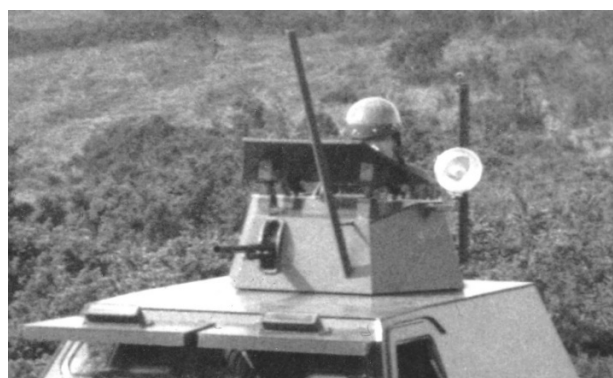
To give the gunner protection against this tactic a wire deflector or cutter was welded to the turret. Former RUC Shorlands that were issued to the UDR were modified in this way. Some Shorlands that were likely to be the tail vehicle had an additional cutter giving the gunner protection when the turret was reversed when giving 'rear cover'.

Note the supporting strut giving a forward off-set allowing the turret hatch to open fully. The disadvantage of a welded cutter was that it was rigid and could do damage to the roof of say a garage.

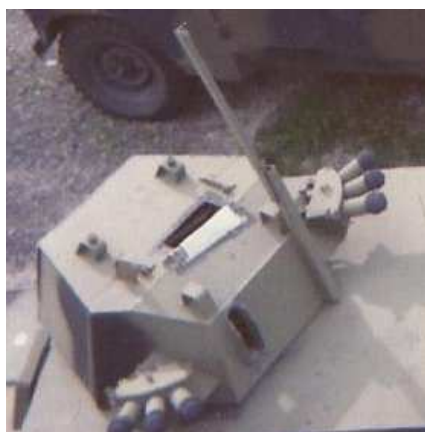
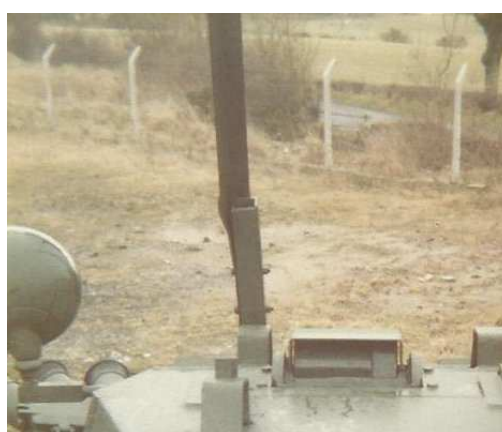
Less common was this rather neat bolt-on cutter that did allow the roof hatch to opened fully.

For a little while I did have one of these cutters fitted and nearly ripped open the roof of my garage because I forgot to remove it. As a failsafe precaution I fitted nylon nuts and bolts that snapped whenever I forgot to unbolt the cutter after a trip out.

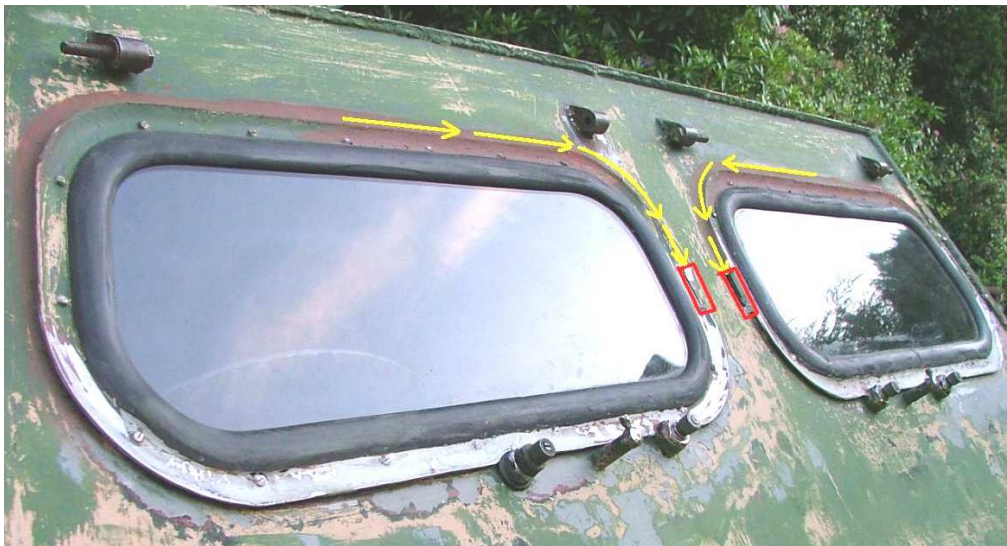
The two windscreens are supported by rubber edging held to the body by everted steel frames. The shape of the frame is such that it provides a degree of guttering so that trickling water is deflected from dribbling over the windscreen. Unfortunately this deflected water is encouraged to enter the cab via the rectangular holes provided for the visor lift arms.

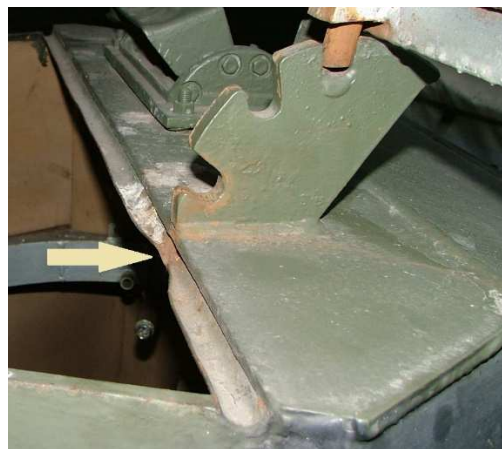
The hatch in the roof of the turret is hinged, there is a small gutter that runs the width of the join. No thought seems to have been given to the fact that when the hatch is lowered, the gutter gets progressively ripped by the spring-loaded bolt that sets the hatch angle.

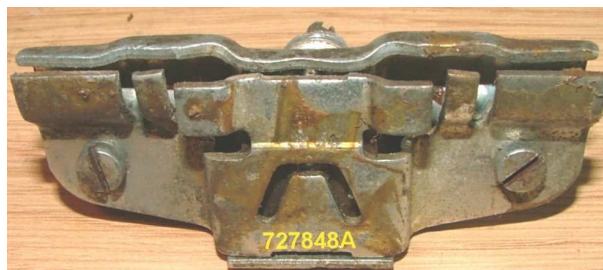
One wiper arm failed where it engaged with splines on the wiper arm spindle. I thought it would be a simple matter to fit a replacement. The part number 727848A stamped on the side yielded no results from Land Rover dealers and in the Mk 1 parts book, the part was only identified with a number unique to Shorts. The Mk 3 parts book identified it as Lucas 72849. The MOD contracts identified it as 54710357. This appears not to be a Land Rover part at all but for some other as yet unknown vehicle.

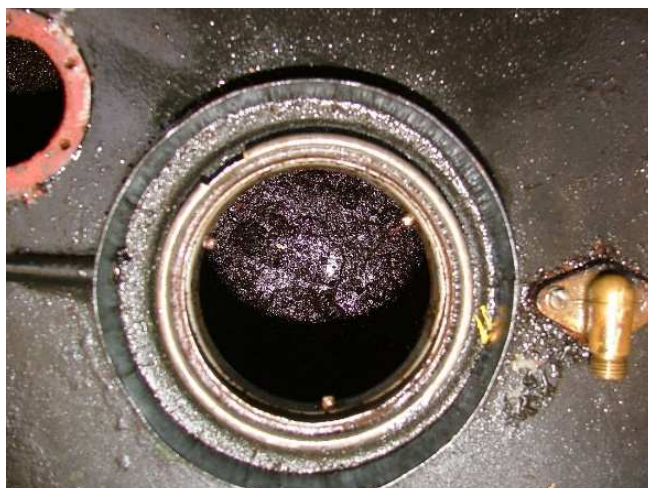
If modern petrol is left in the tank for several years it will turn into a nasty brown gunge.

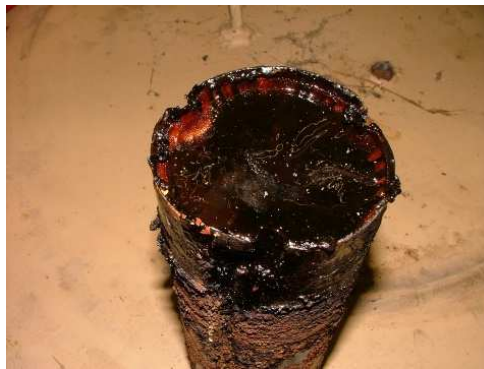
That shows the effects of modern fuel after 12 years, although it does seem to discourage rust! Where a tank has not seen fuel of any sort for a long time then rust will set in. When I first had my Shorland the base of the tank was pretty rusted and either needed replacing or repairing.

But in the case of the filler tube it is best just to replace it.

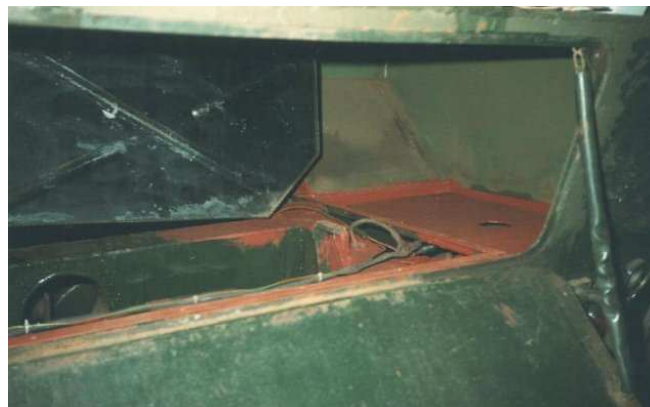
The fuel tank is not a standard Land Rover item as it has been extensively modified by Shorts to fit over part of the wheel arch. It cannot be extracted through the boot hatch and with the centre floor panel removed it cannot be dropped down through the chassis members on a Series 2A. I was told by one owner that with a bit of jiggling it can be dropped through on a Series 3 chassis. Another owner found he needed to lift the whole body from the chassis to remove the fuel tank.

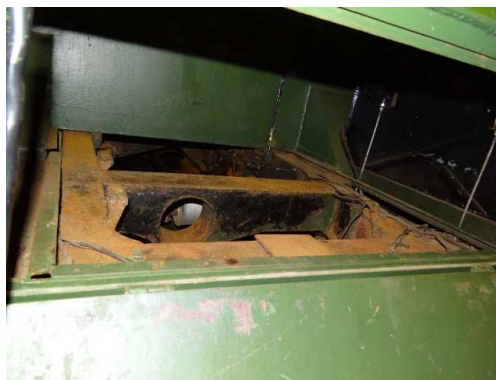
The rear boot accommodates the spare wheel and depending on the model one or two fuel tanks. The large central panel is secured by 20 hexagonal headed Whitworth  $\frac{1}{4}$  in. bolts these should be straightforward to remove. However they are very likely to be severely rusted and may need to be cut off with an angle grinder. This will allow good access to inspect and restore much of the rear chassis.

To be really authentic they should be replaced with the same. But I didn't have any Whitworth bolts, so even fitting UNF or metric replacements would be a compromise. I made a further compromise by deciding to fit Rivnuts (nuts inserted with a rivet). This of course means that the floor plate can be removed by one person without needing an assistant underneath undoing the nuts. Using dome headed bolts makes the task quite easy. I feel that a more convenient access to this large area of rear chassis greatly increases the chance of regular maintenance, which is likely to prolong the vehicle's life.

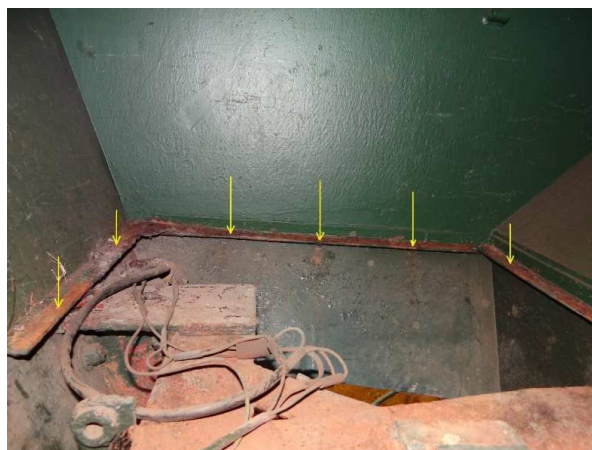
The same arguments apply to the adjacent floor panels either side, but they present an even greater challenge to remove. Firstly these Whitworth bolts have countersunk slotted heads that were severely rusted and the nuts underneath are not axially accessible due to the inward slope of the armour.

Although the countersunk heads were rusted in place, it was impossible get a socket or ring spanner onto the nuts underneath. I used an Irwin stud extractor that was able to grip the nut albeit obliquely and was able to snap the bolts.

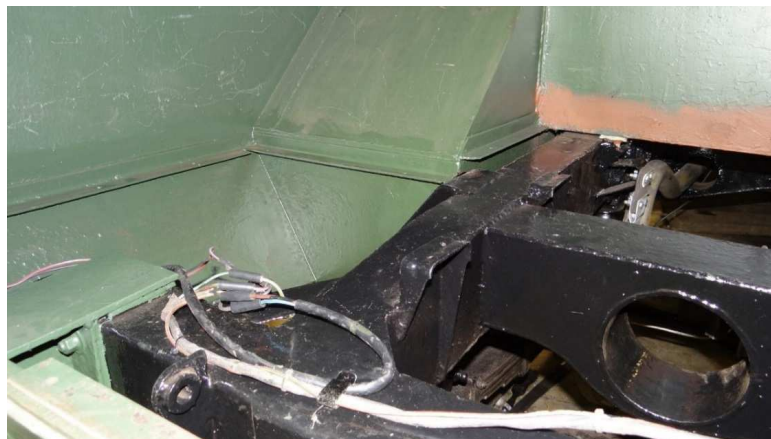
The brown colour of the metal work is from the effect of “Kurust” anti-rust treatment, prior to painting.

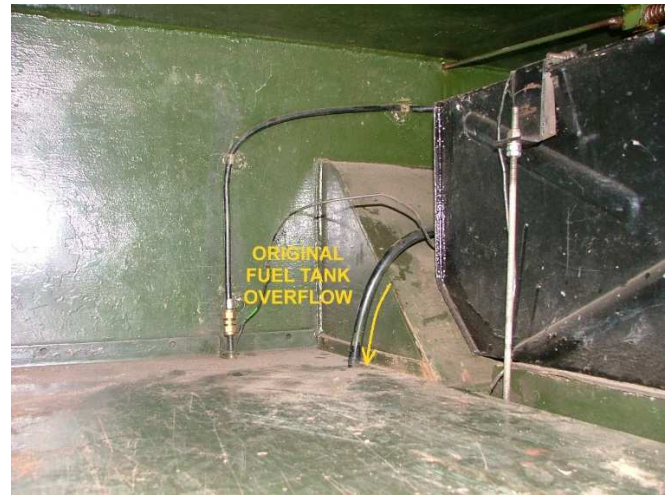
This only applies to Mk 1 & Mk 2 Shorlands where the exhaust tail pipe exits behind rear right wheel. Unfortunately this is immediately beneath fuel overflow pipe!

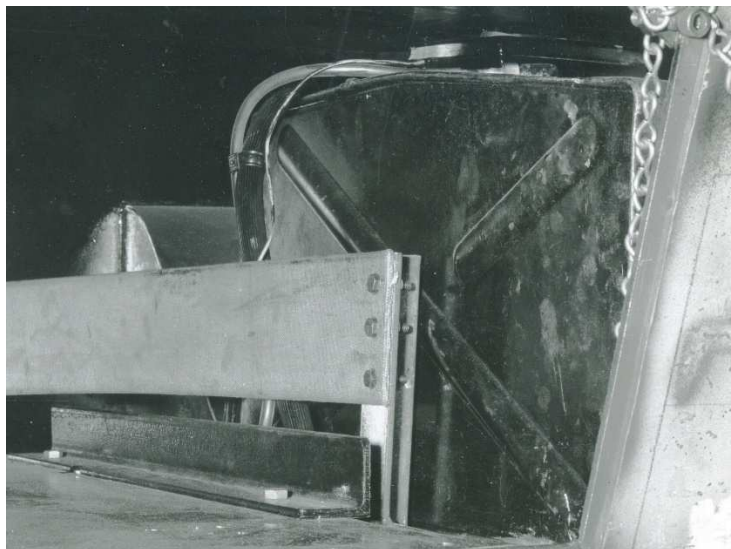
The modified position is in a very similar location in the first prototype.

Incidentally the horizontal band was an idea that was tried to assist in the removal of the spare tyre.

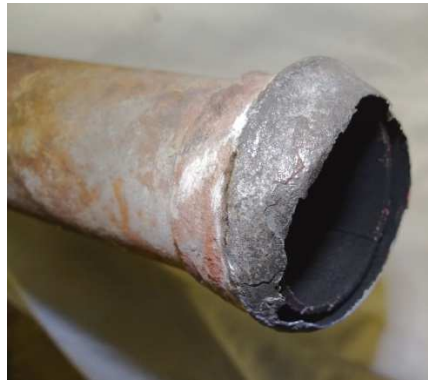
I kept getting leakage of exhaust gas from around the manifold to the down-pipe junction. Regularly tightening the three securing nuts did not solve the problem and even reassembly with exhaust sealing paste was futile. The effect of a blowing exhaust at the junction rapidly caused erosion of the rim of the down pipe.

Although this might seem to be purely an exhaust sealing problem, the real problem was that the engine and gearbox mounts had failed and were not holding engine securely. The engine was not secured but was merely resting upon broken rubber mounts. This meant movement of the engine was soon causing leakage at the manifold to down-pipe junction where a small leak was rapidly eroding the downpipe rim.

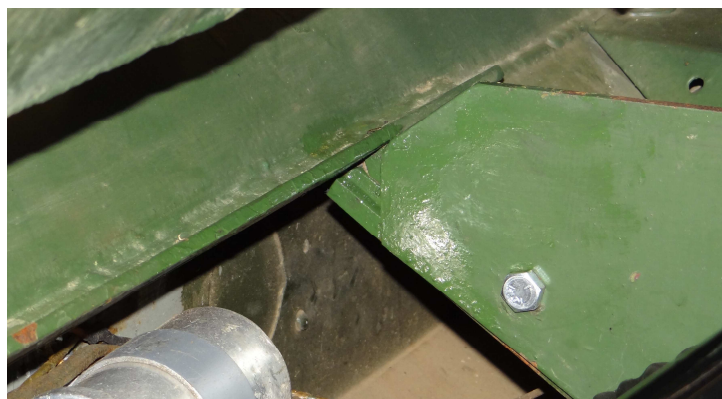
It was necessary to undo the bonnet support arm and tie the bonnet to the turret. This needs to be done securely as the bonnet with its armour is very heavy!

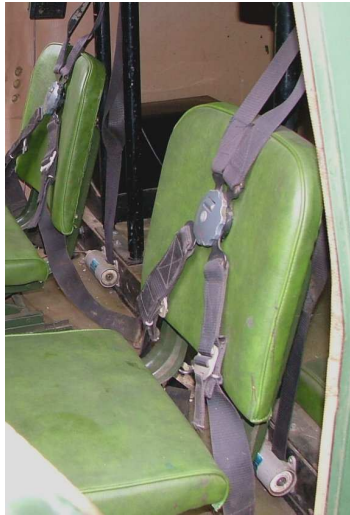
The front seats in a Shorland were provided with diagonal and lap type seat belts, but MOD Shorlands were fitted with a four-way harness.

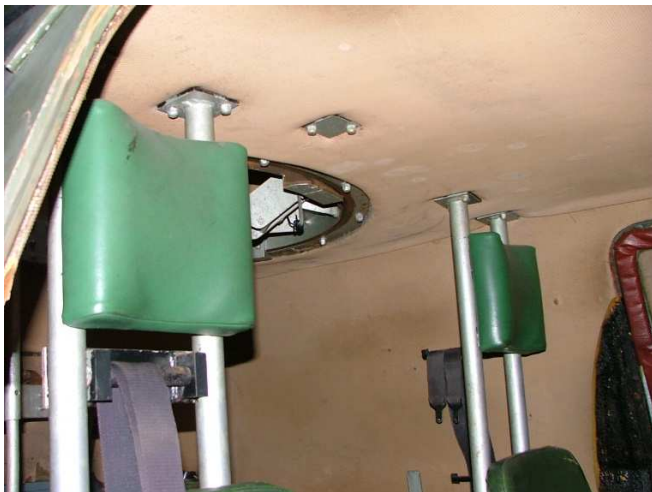
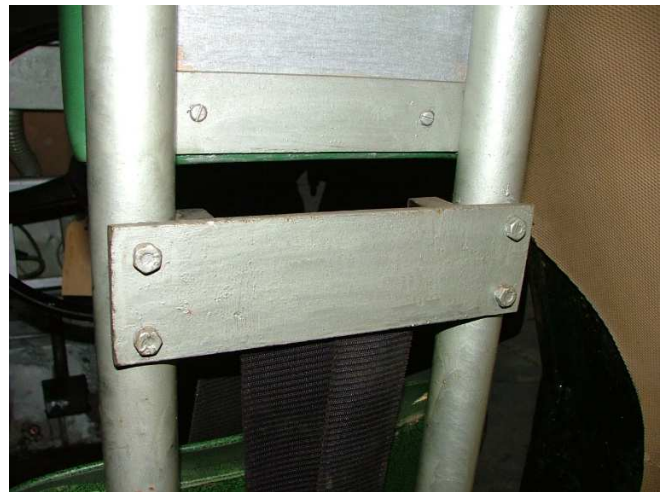
The shoulder straps are supported by a horizontal bar mounted behind each seat on a pair of tubular struts. Each pair of struts also provide a rigid head support and also give additional support for the roof in place of the single strut originally fitted.

It is not unusual to find that the support bars are missing, indeed the one on this passenger's seat is absent. For those who wish to make replacements I took some measurements.

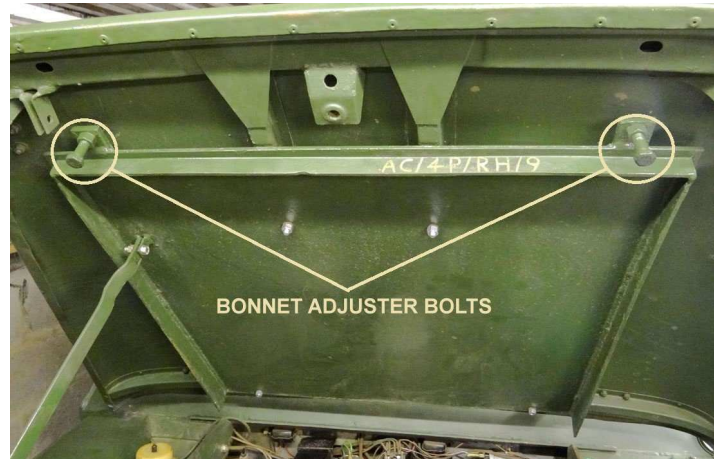
The height of the bonnet is adjusted by means two bolts at the front underside of the bonnet.

The armour makes the bonnet quite heavy and with time the fibre pads became compressed and eventually crushed. Periodic adjustment of the bolts is necessary to maintain a ¼ inch gap between the armour bonnet plate and the top of the radiator armour. In my experience the gap needs to be greater as the bonnet armour crushes the copper overflow pipe of the radiator.

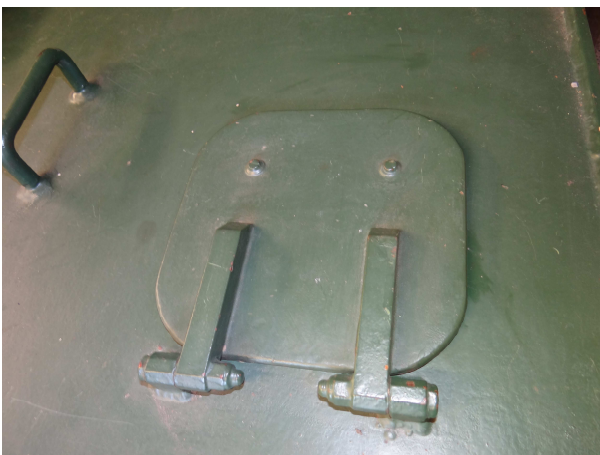
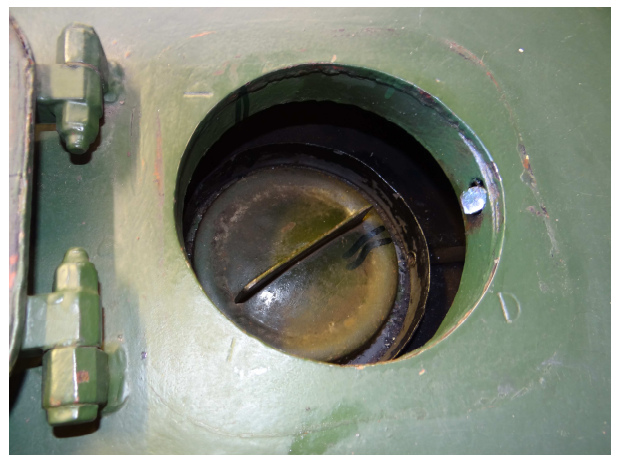
The fuel security was still not good enough, even without the Allen key the screws could be undone by using a pair of adjustable grips. So in the production vehicle the fuel flap was secured by a spring-loaded catch operated from within the cab. It was a simple matter for the gunner to reach down and pull the round knob releasing the flap so that a second person outside the vehicle could lift it up.

Therein lies the problem of needing a second person to open the flap, because many private owners will be in the vehicle unaccompanied. It is possible for one person to open the escape hatch and with one hand pulling on the release knob whilst lifting the flap with the other hand. This is somewhat tedious and often impossible if there is some kit in the rear of the cab.

I found the way round this was to undo the release knob and locking nut, slide a tube over the control shaft and then a wing nut. The locking nut and knob were then screwed on in their original position.

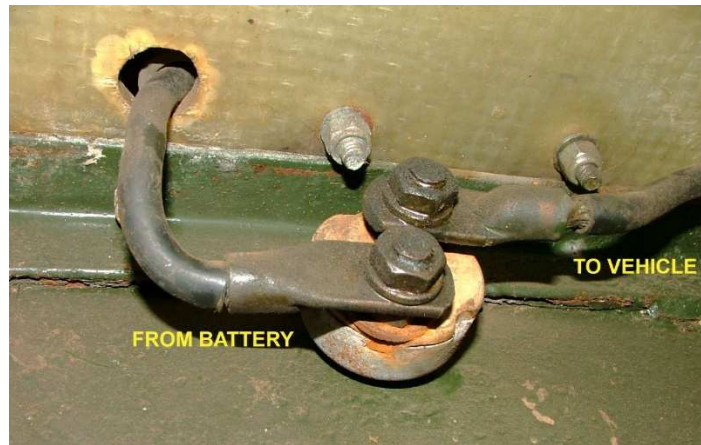
The Shorland's isolator is within easy reach of the driver's right hand reaching back. The position of the switch is not particularly safe when viewed from beneath. Any loosening of the nut for the vehicle connector could cause a short circuit to the chassis. The original switch was rated to withstand 500 amps for 5 seconds during which considerable damage could take place.
